# Walk Around

## Focke-Wulf Fw 190A/F

Walk Around Number 22  
squadron/signal publications

By Malcolm Laing and E. Brown Ryle

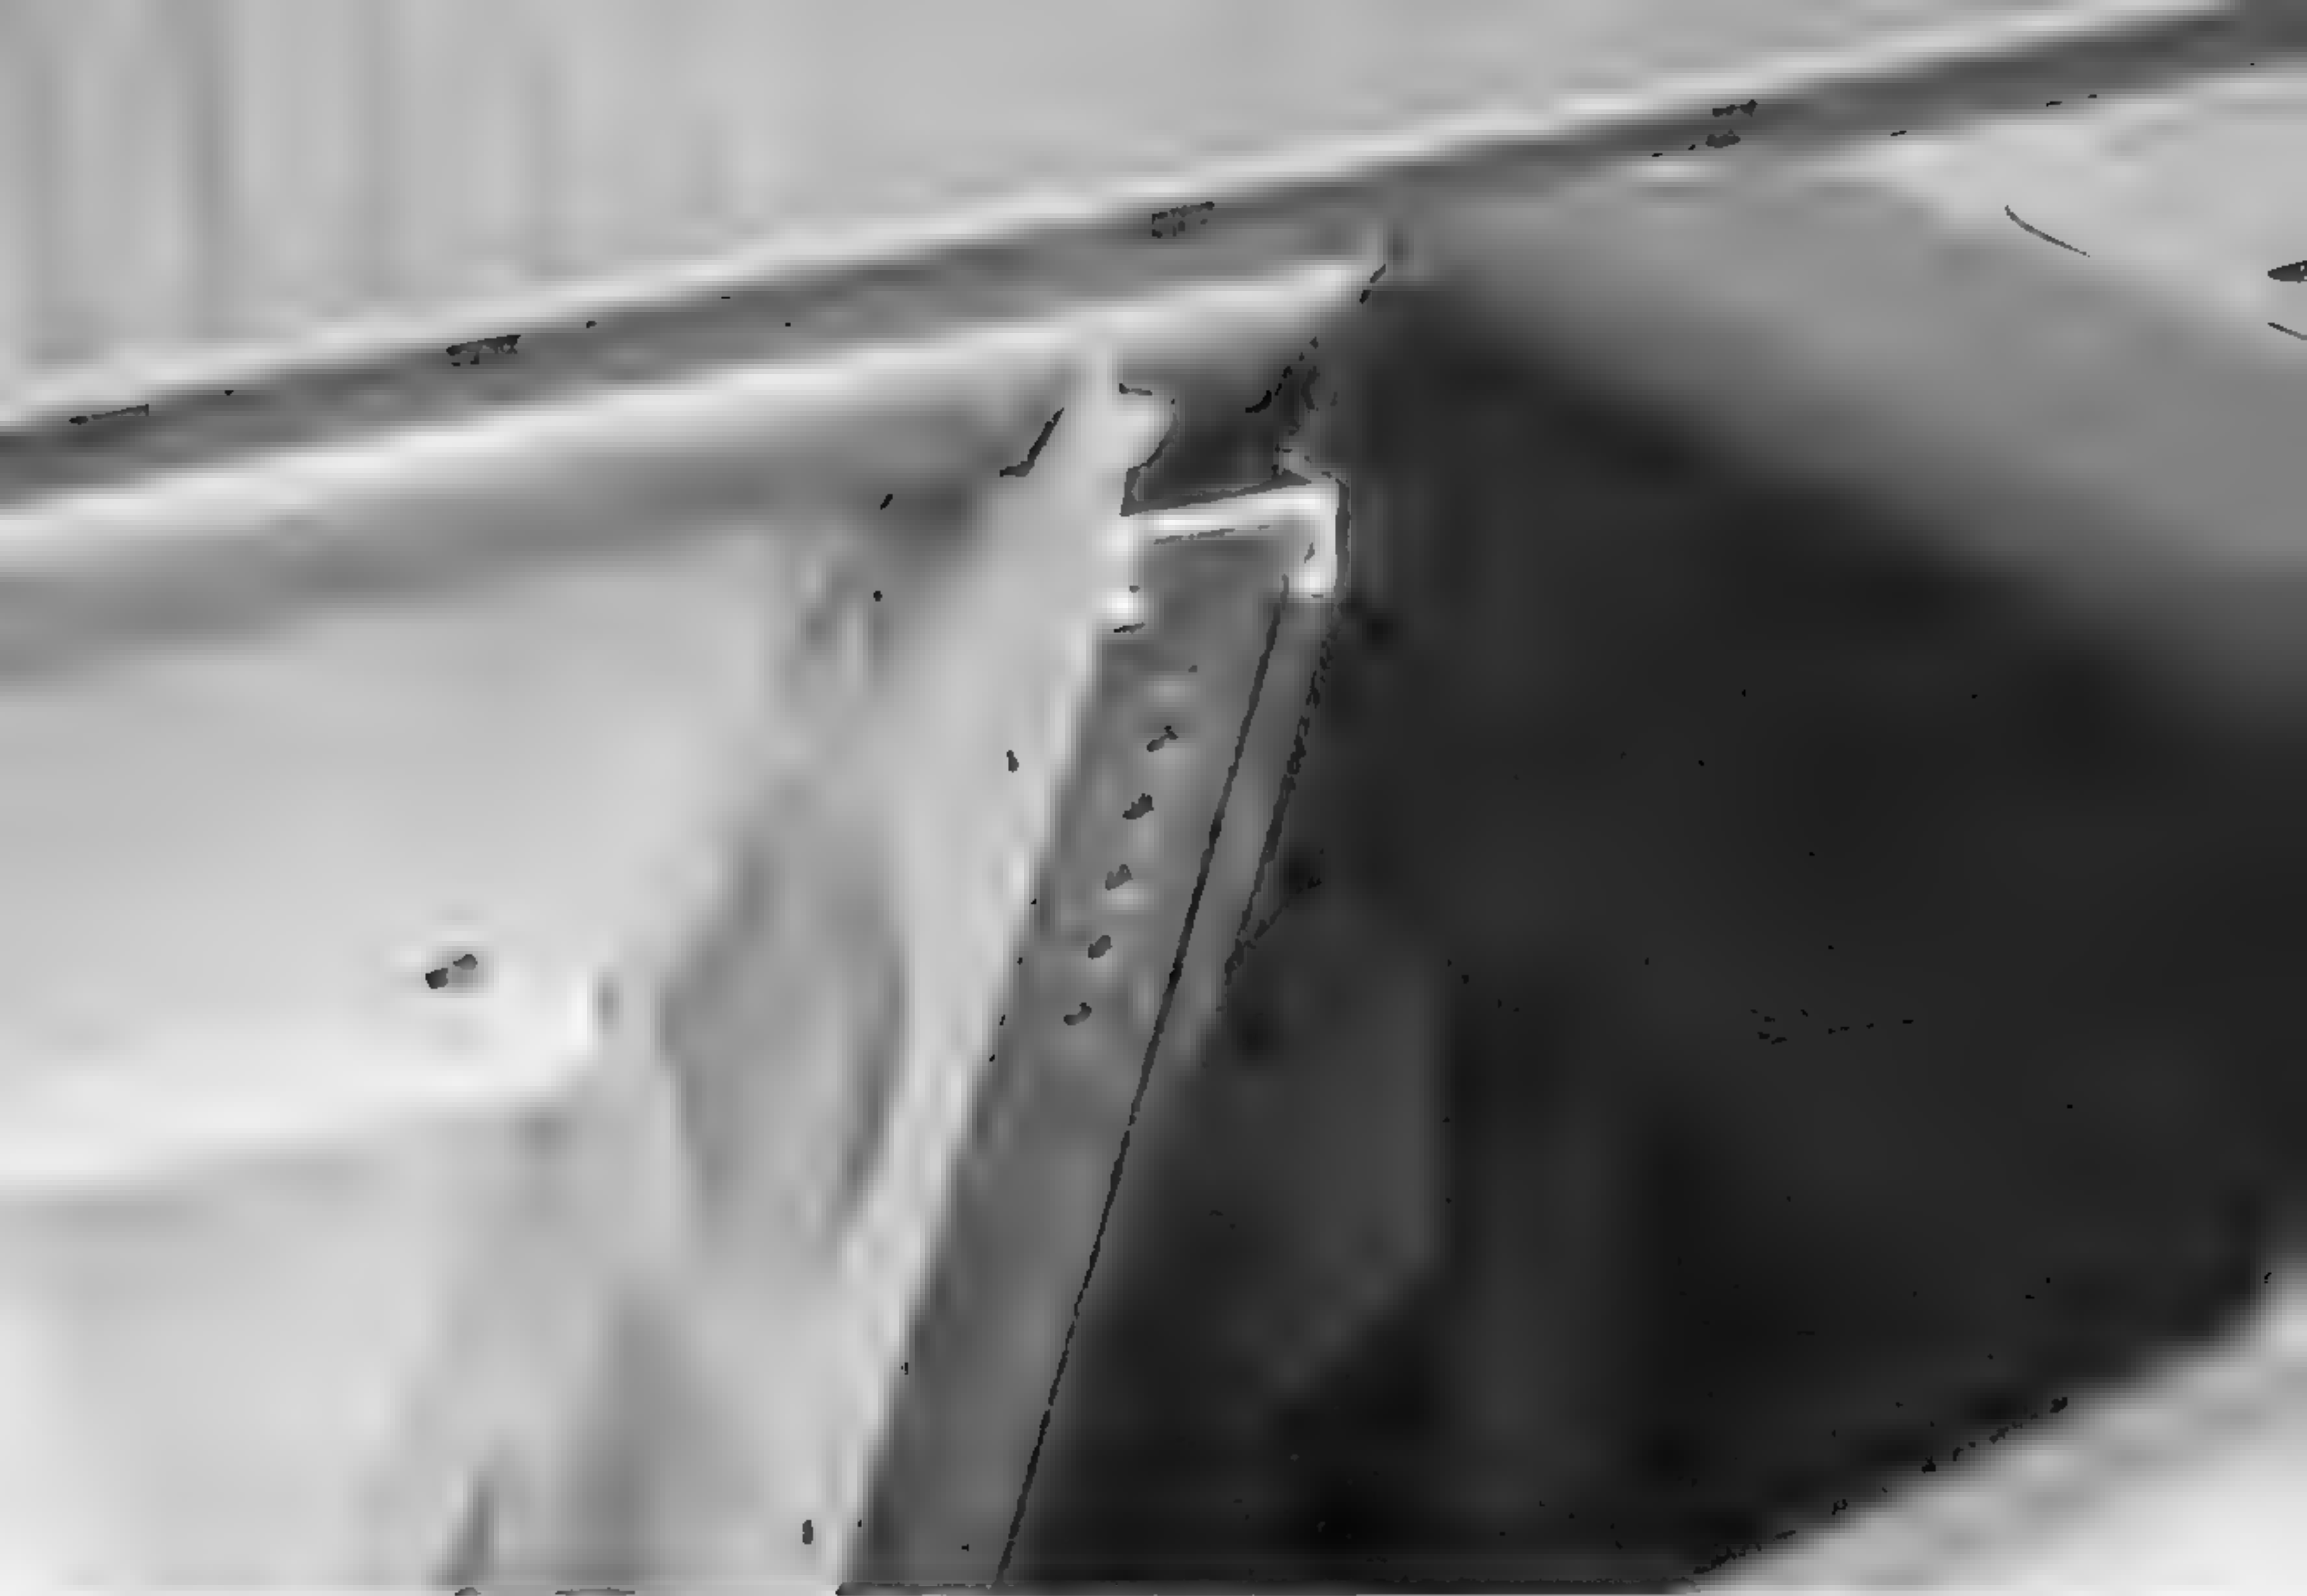
The Fw 190A pilot's seat's four rollers fit into seat guide channels located at the aft sides of the cockpit. Two small levers placed on the top rollers adjusted the seat up and down. Pushing the levers in or out allowed locking studs to retract or extend into one of six holes placed inside the seat guide channels. (Lainq)

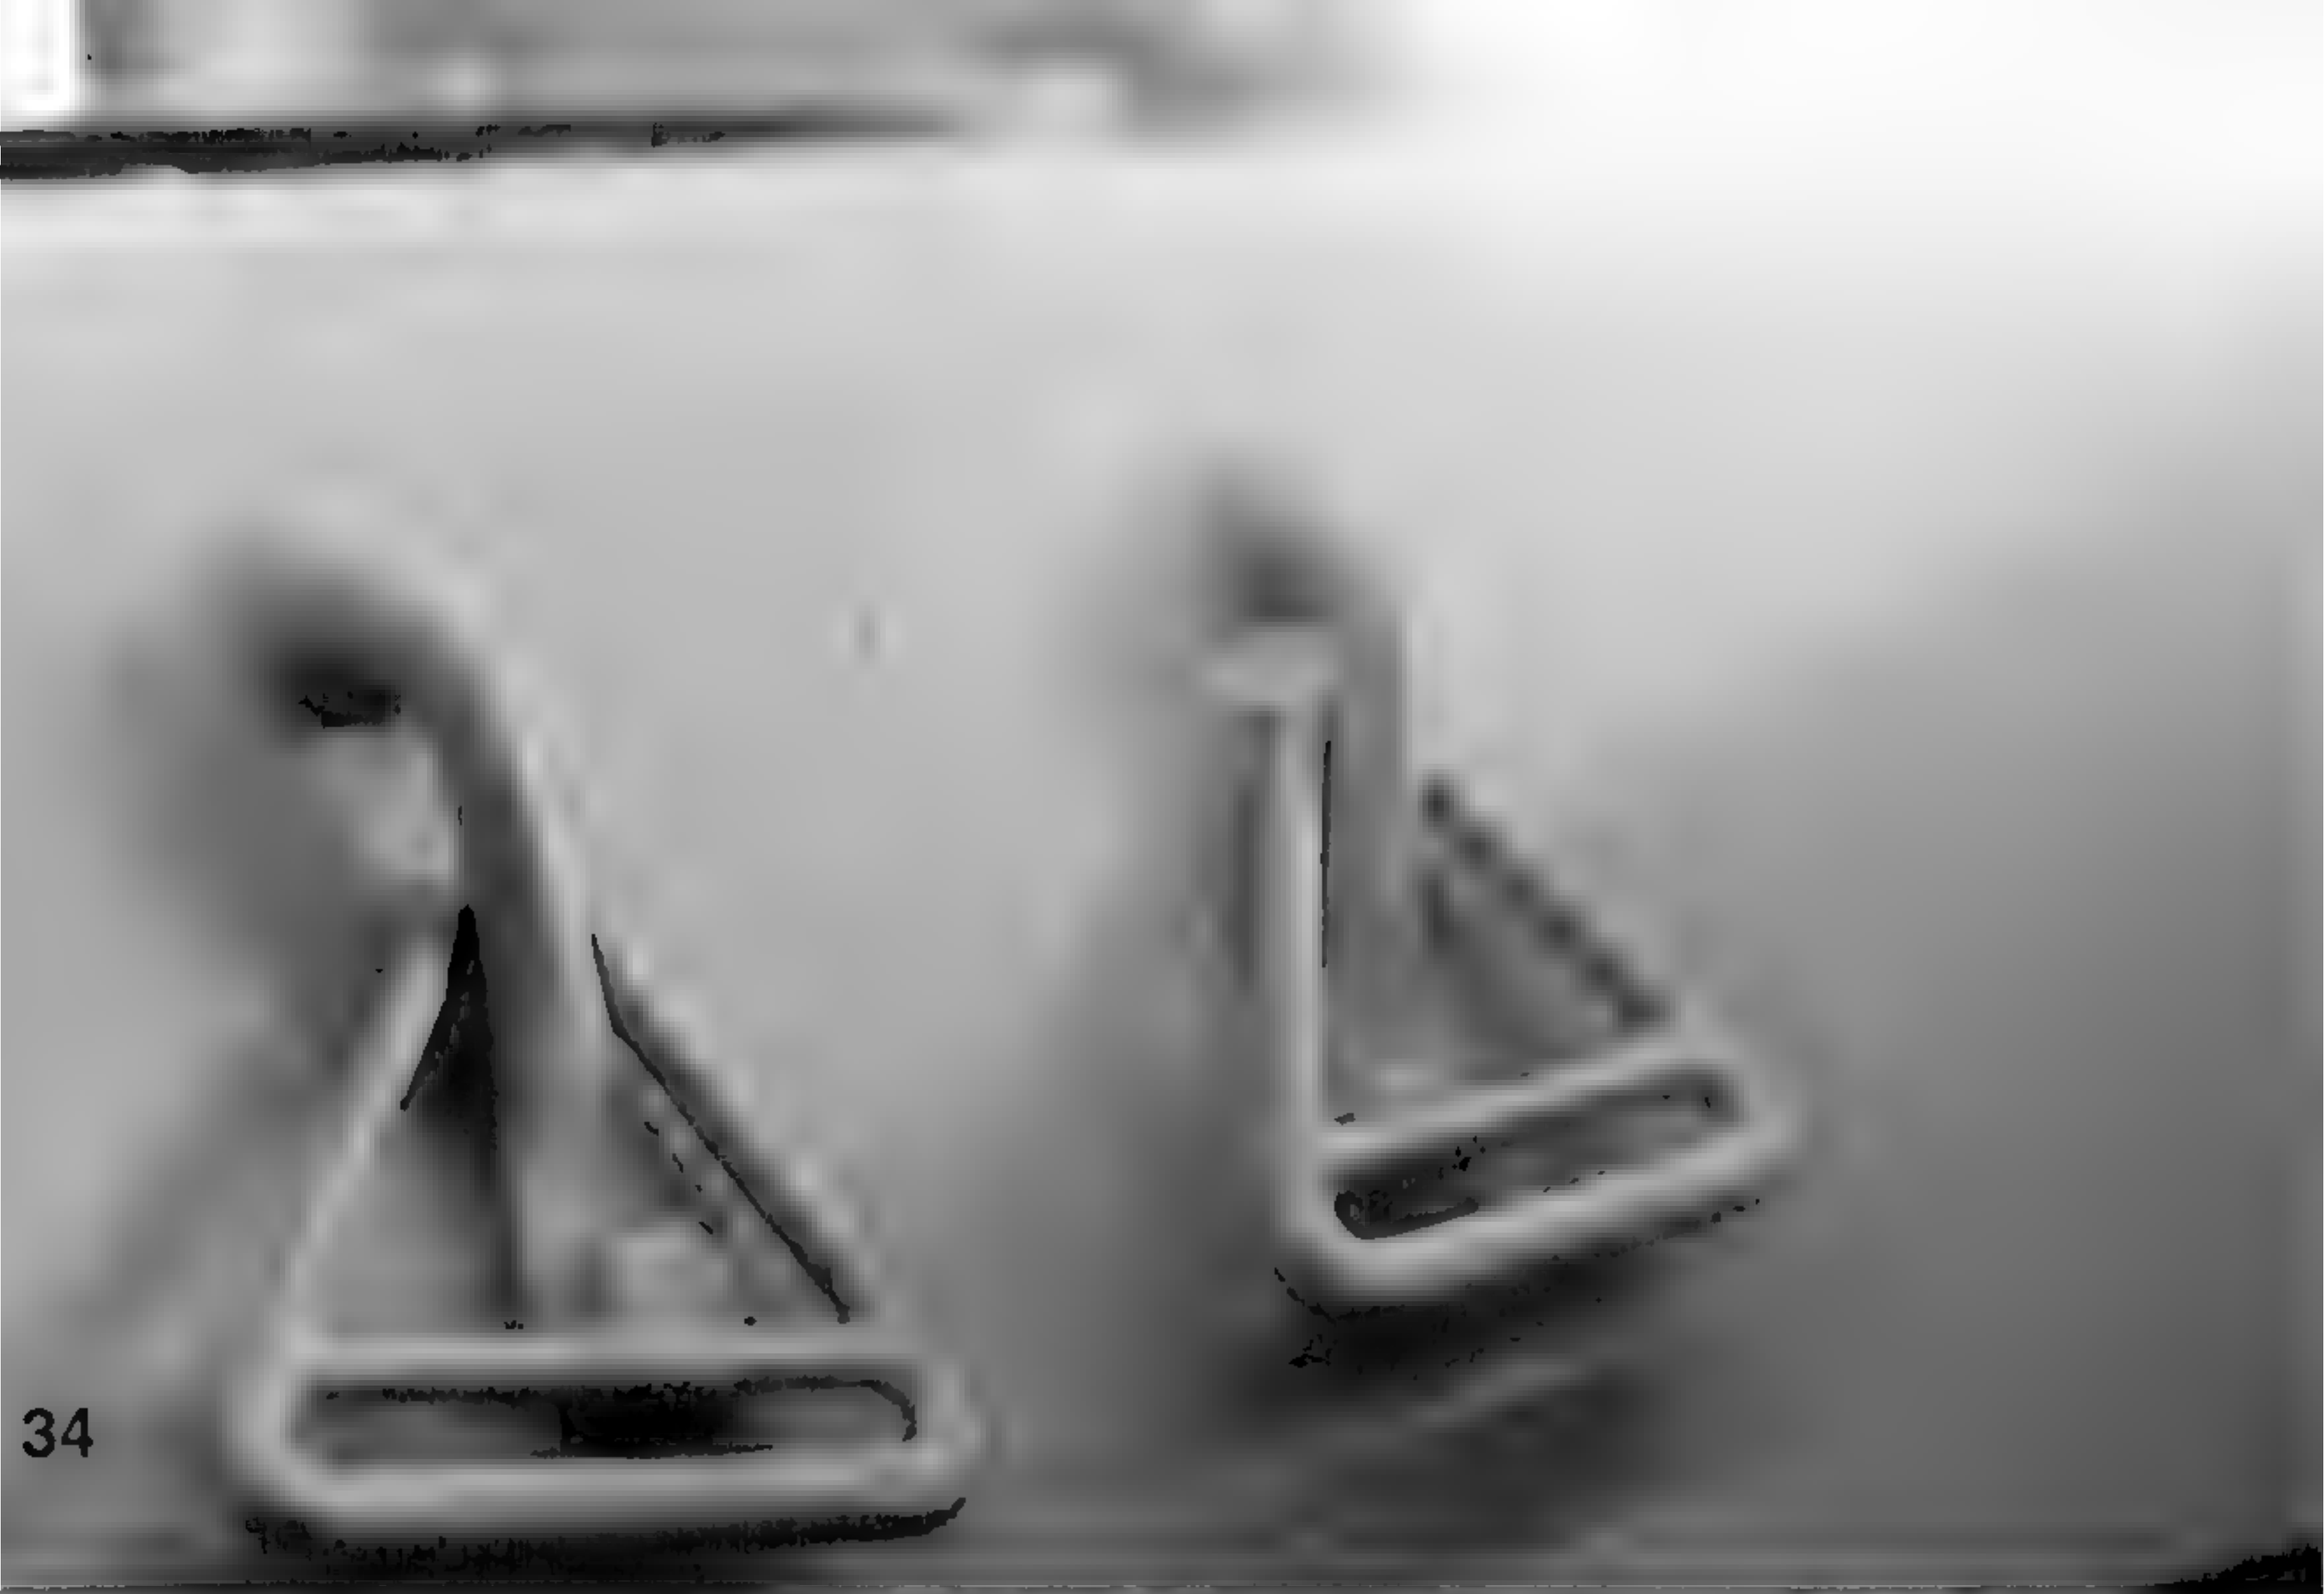
A black and white photograph showing two metal shoulder harness fittings mounted on a flat, metallic surface, which is the aft upper cockpit armor of a Fw 190A. The fittings are L-shaped, with one vertical and one horizontal flange. They are positioned side-by-side, with the left one slightly higher than the right one. The background is a light, textured surface.

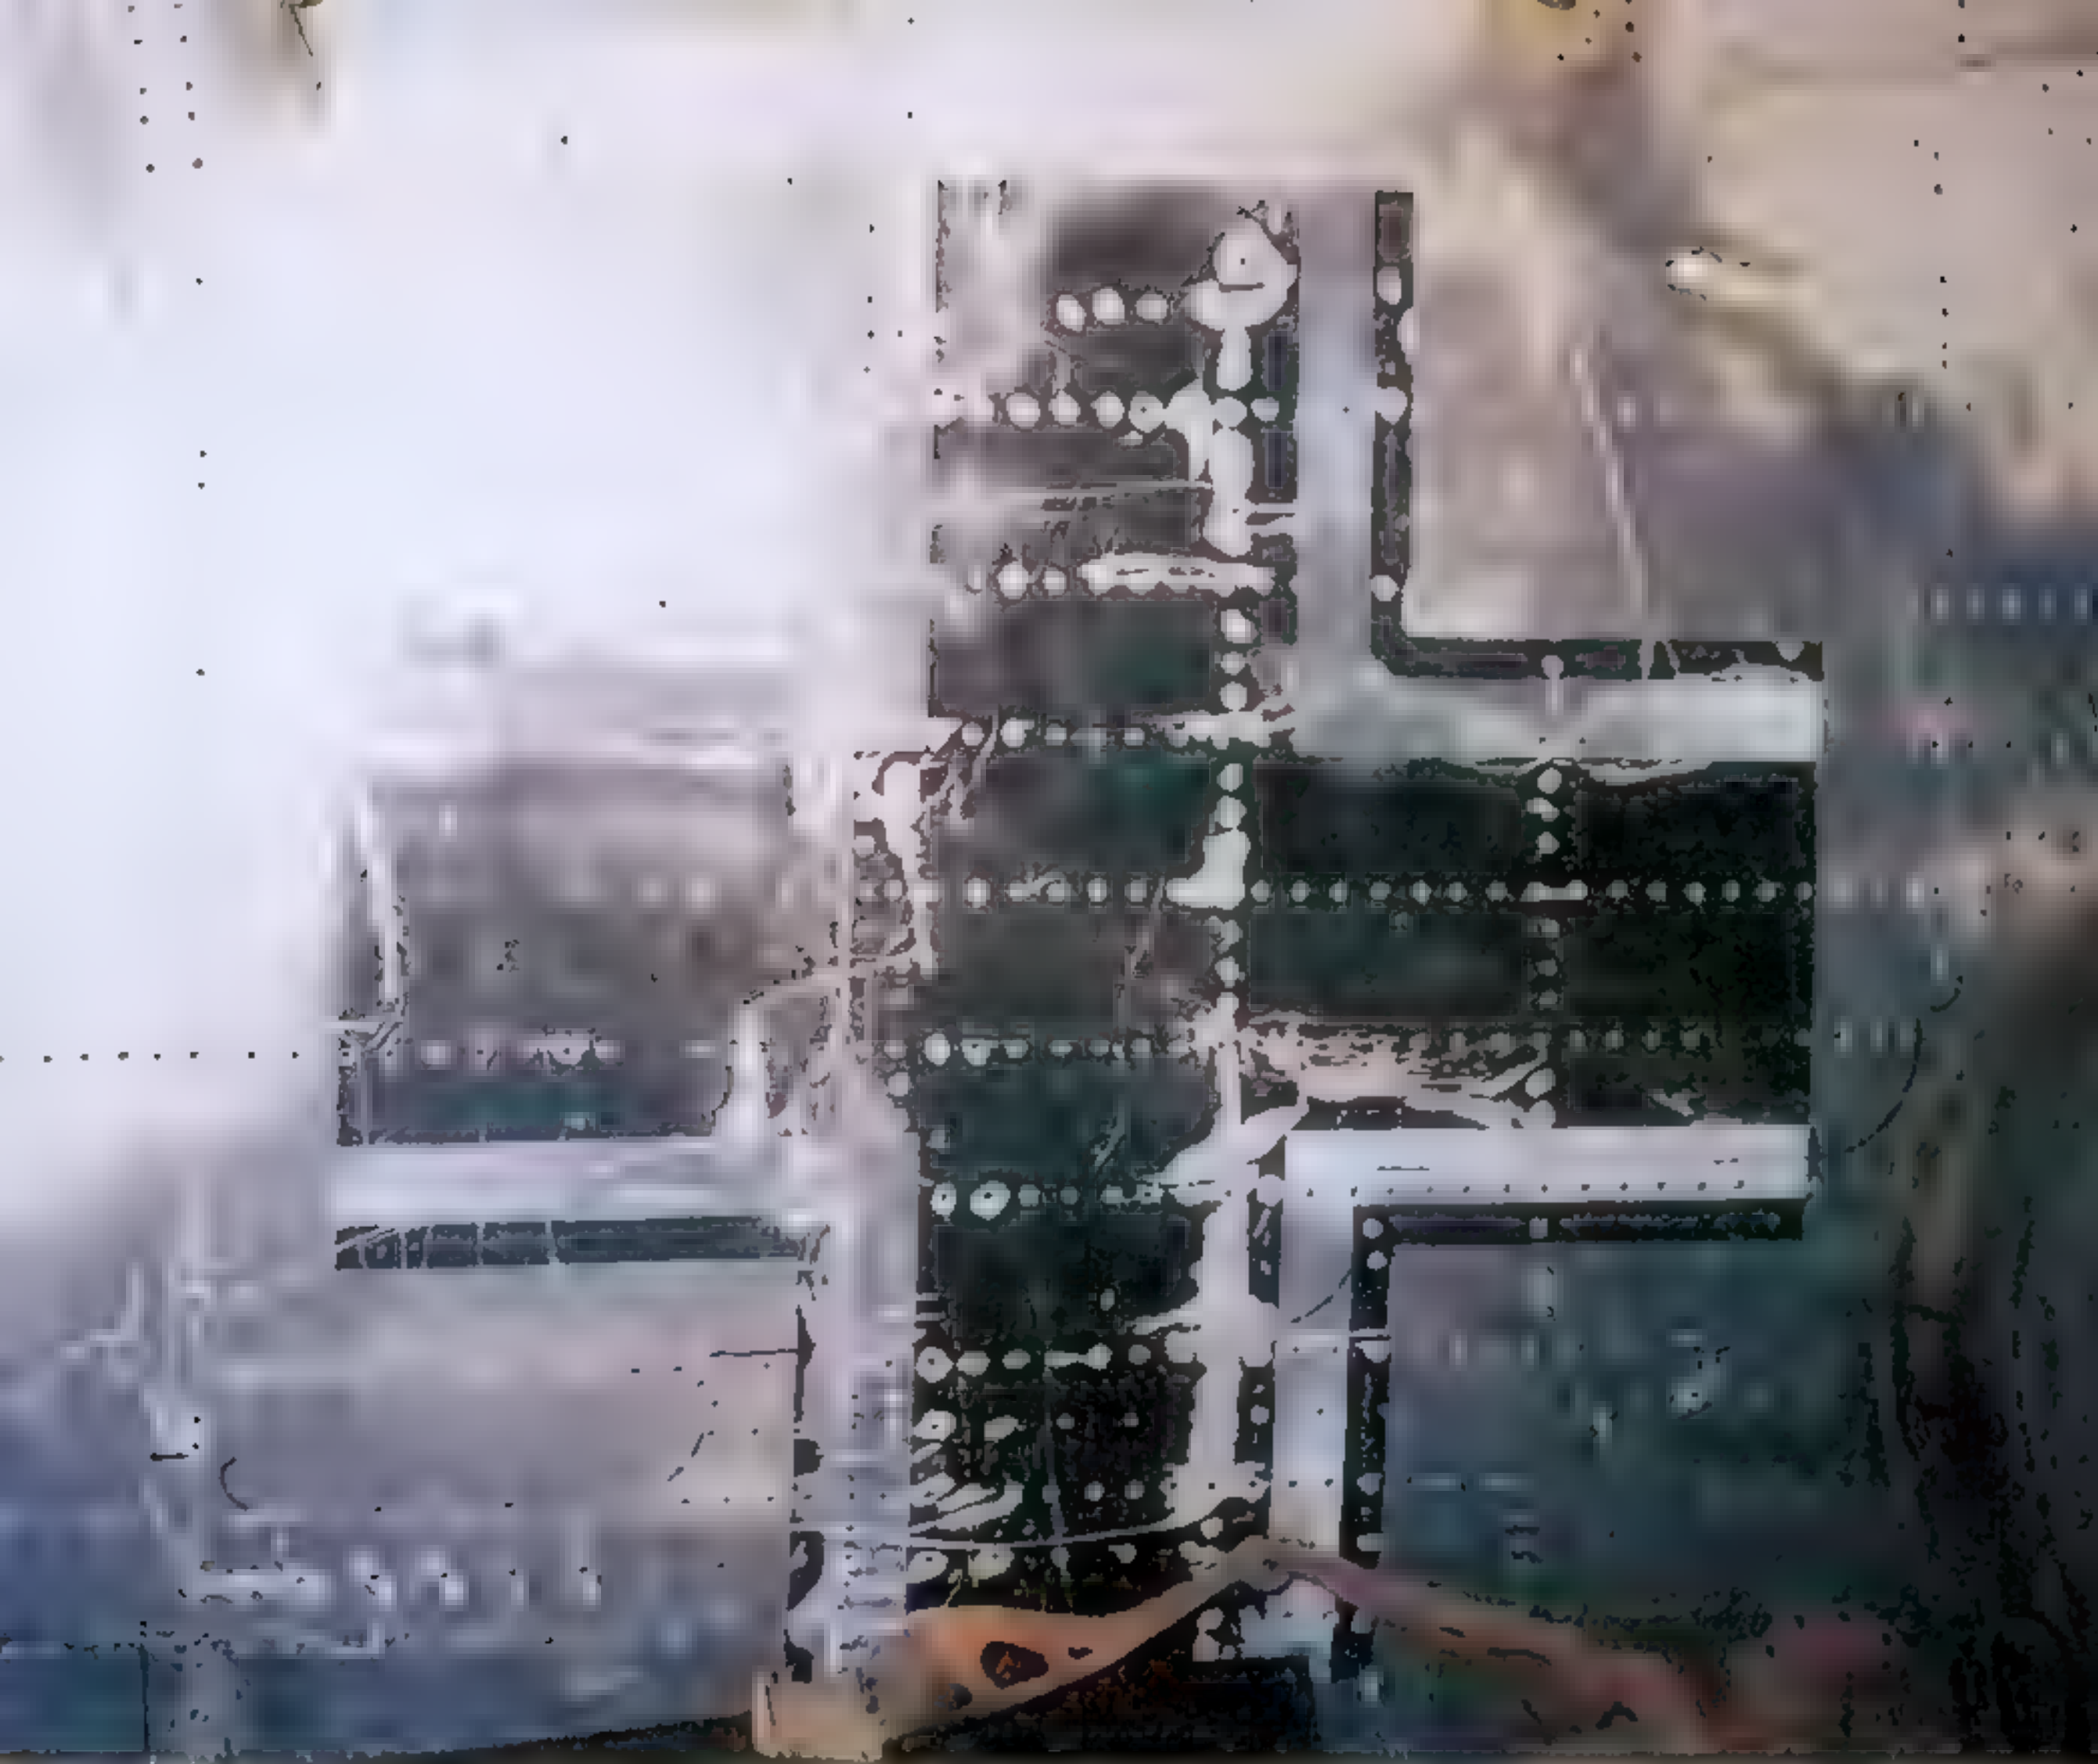
(Above) An outboard section of an Fw 190A-3 starboard wing recovered in Norway reveals wear from nearly 50 years in a derelict state. The wing received a factory-applied coat of RLM 76 Light Blue followed by a single application of RLM 75 Gray-Violet in the standard camouflage pattern for the Fw 190A. The black and white wing cross was applied over the camouflage. This aircraft belonged to JG5 and came from the final batch of Fw 190A-3s built. The wing has since been restored by the Texas Air Museum. (Ryle)

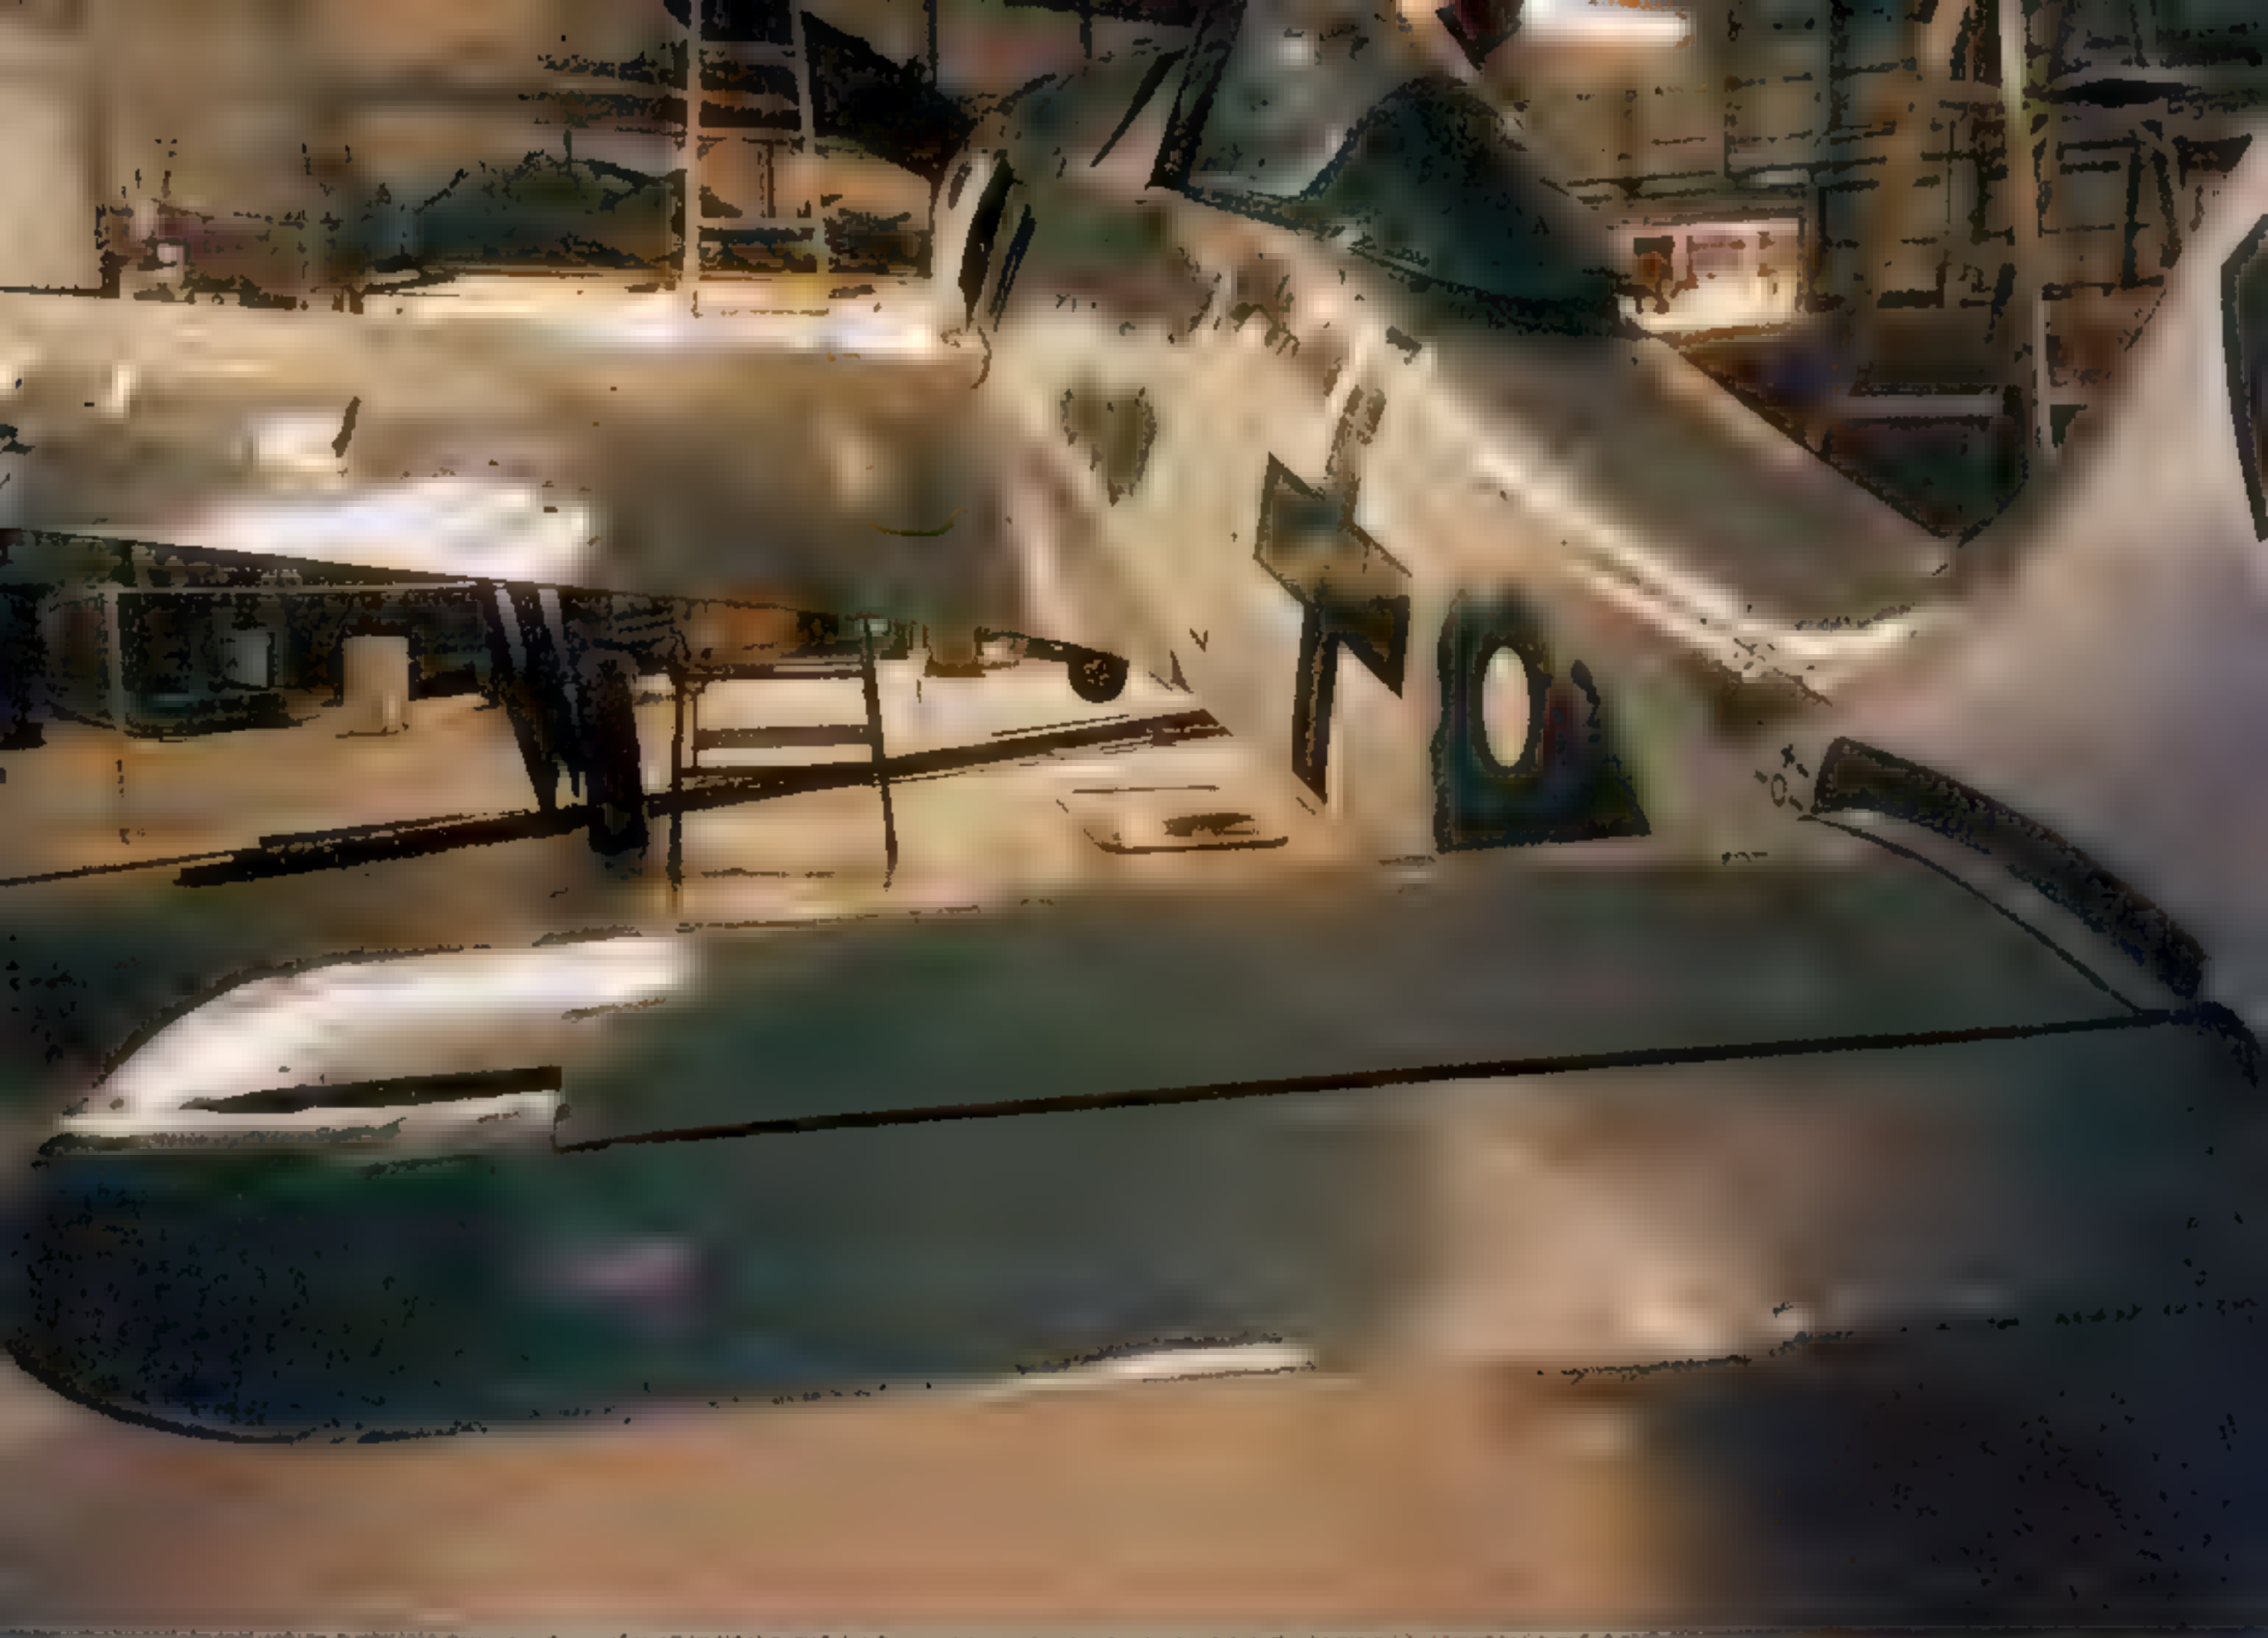
(Above Left) The port elevator has been installed on an Fw 190A-3 under restoration at the Texas Air Museum in Rio Hondo; however, the elevator trim tab has not yet been painted red. The elevators – like the rudder and ailerons – consisted of metal frames covered with doped fabric, which was then painted the camouflage colors. The aircraft was painted RLM 74 Gray-Green (FS34086) and RLM 75 Gray-Violet (FS36122) on the upper surfaces with RLM 76 Light Blue (FS36473) undersurfaces. This Fw 190F-8, White 1, displays a white disc aft of the national insignia, which indicated assignment to the 9 *Staffel* (Squadron), IV *Gruppe* (Group) of a *Jagdgeschwader* (Fighter Wing). (Laing)

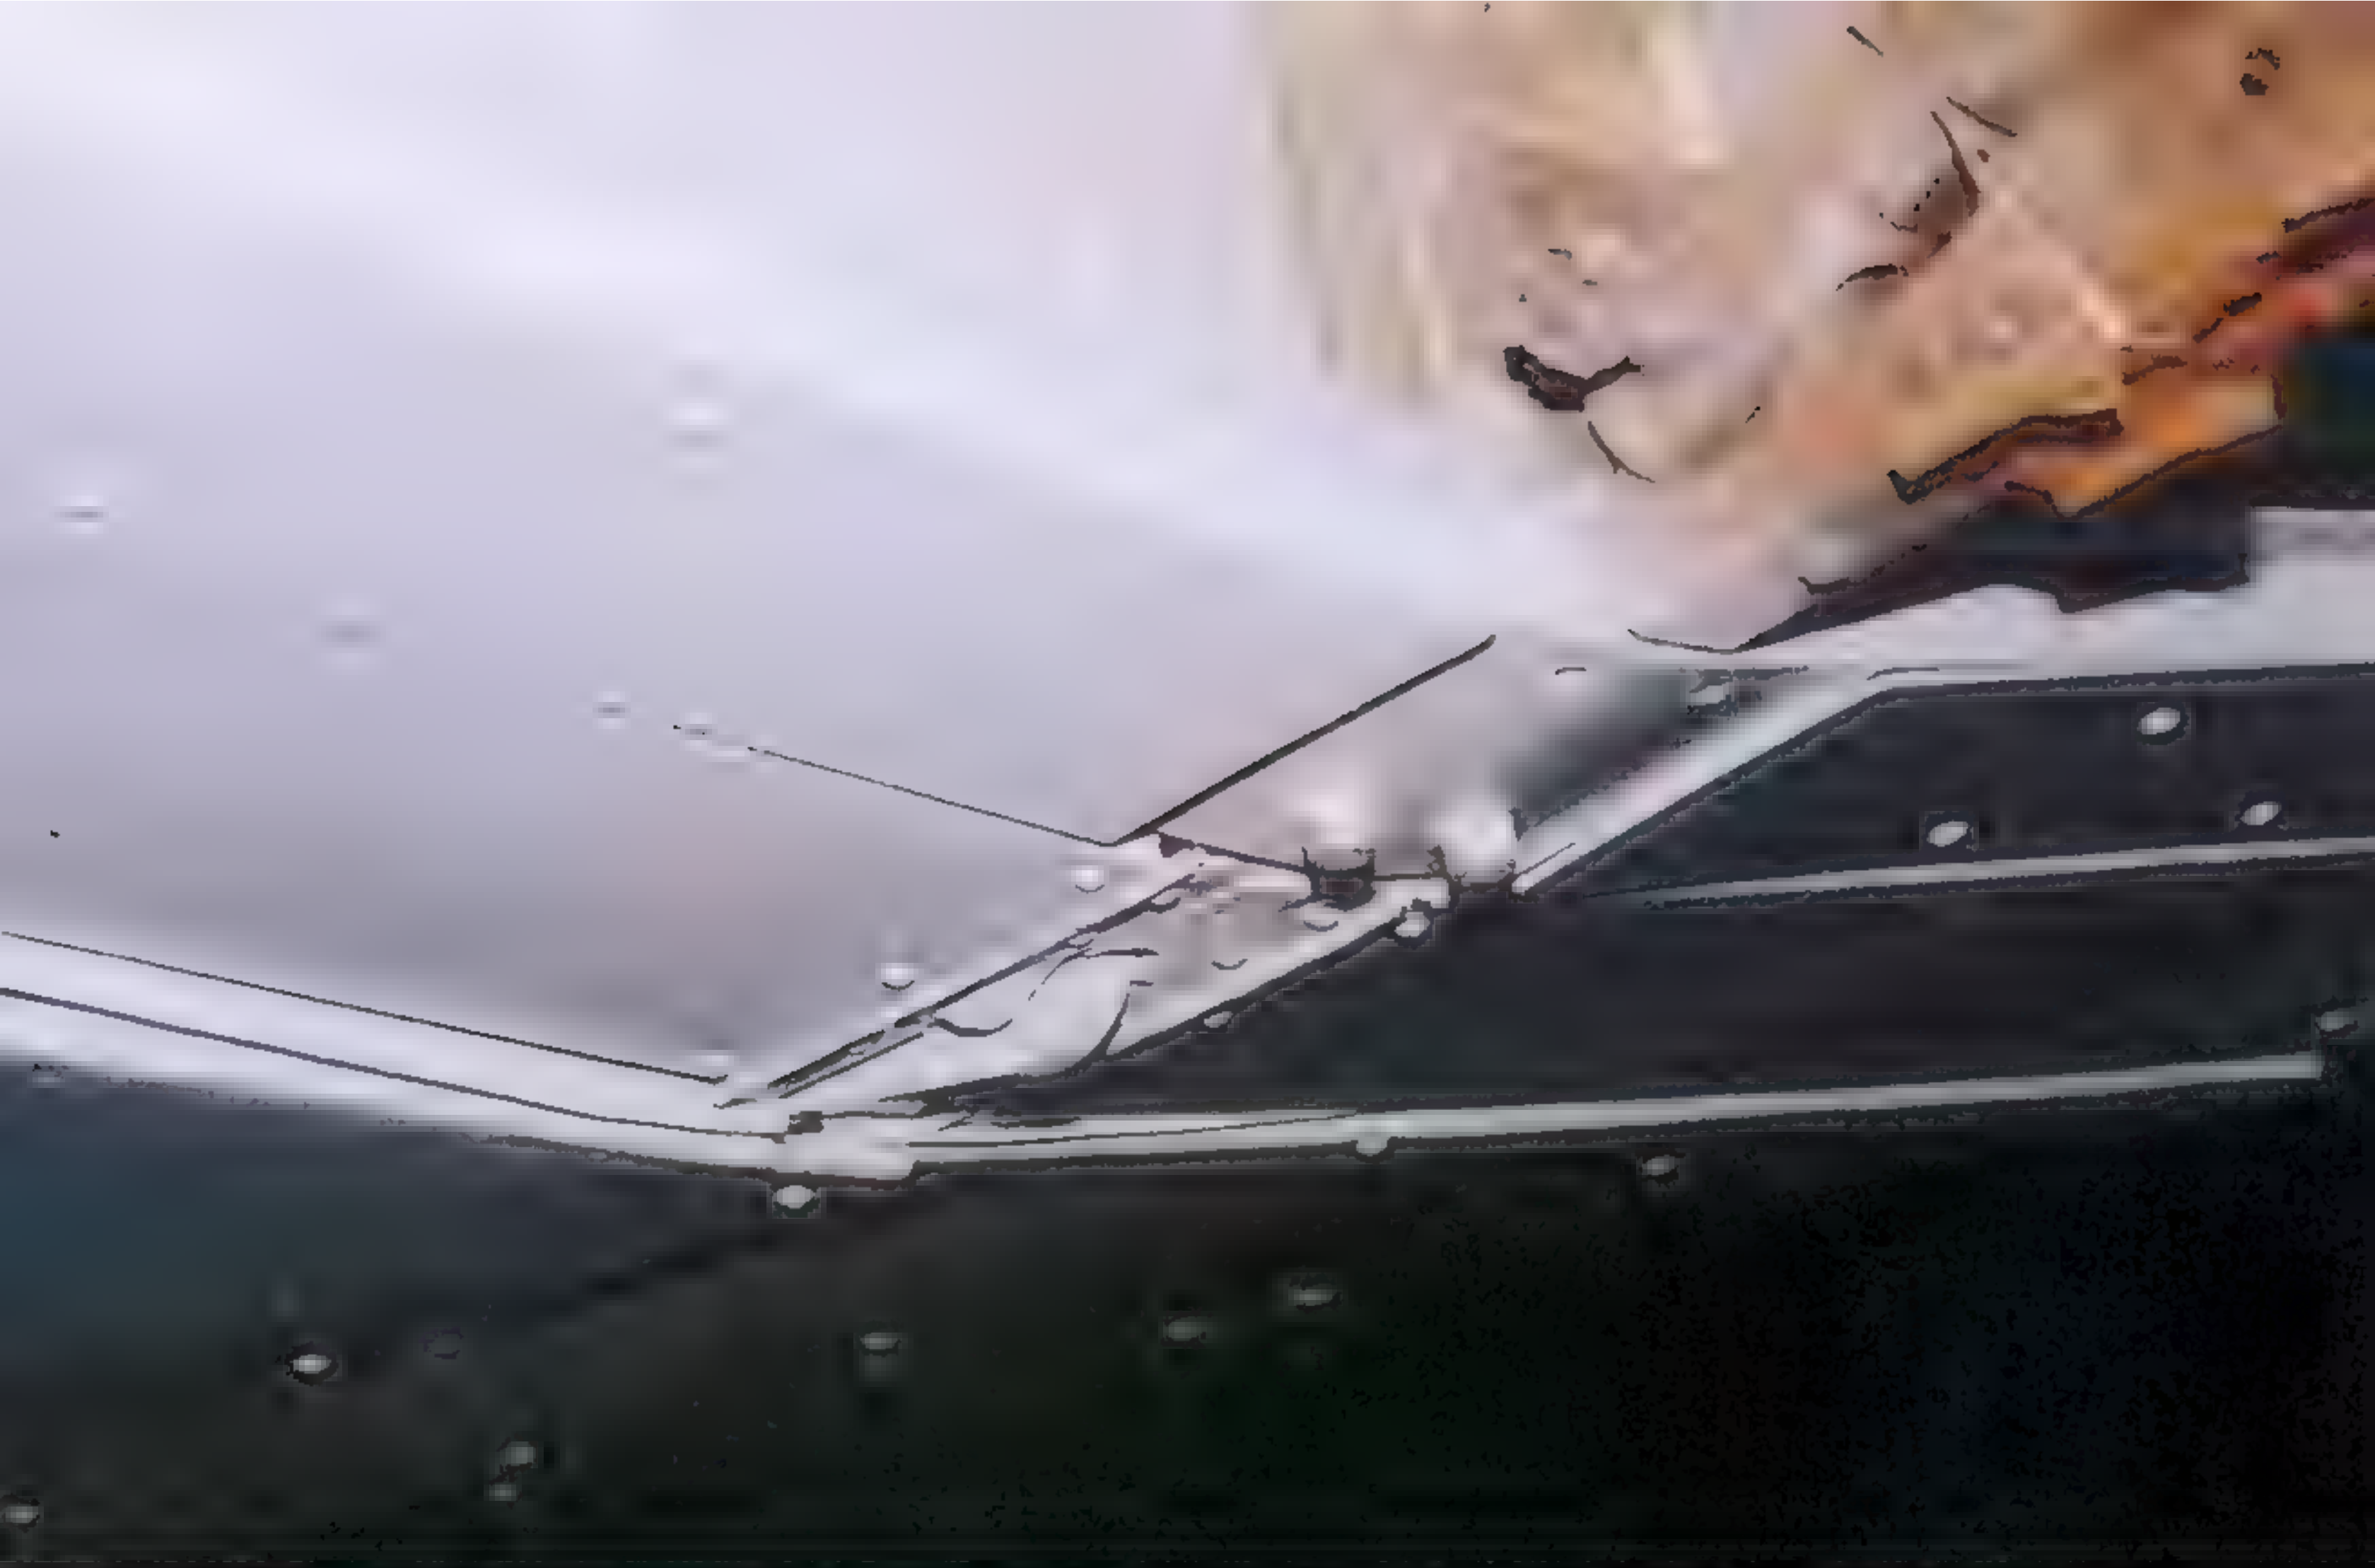
(Left) The small aerodynamic bump on the centerline of an Fw 190A-3 – just behind the wheel well – was common to all Fw 190s. Just ahead of this bump is the forward attachment/pivot point of the fuel tank cover panel over the fuselage fuel tank bay. This fitting is directly between the two access panels for the wing-root 20mm cannon ammunition boxes. The pivot point was covered when an ETC (*Einzelträger C-munition*; Single Rack with High-Explosive Bomb) 501 bomb rack was installed on the aircraft. (Ryle)

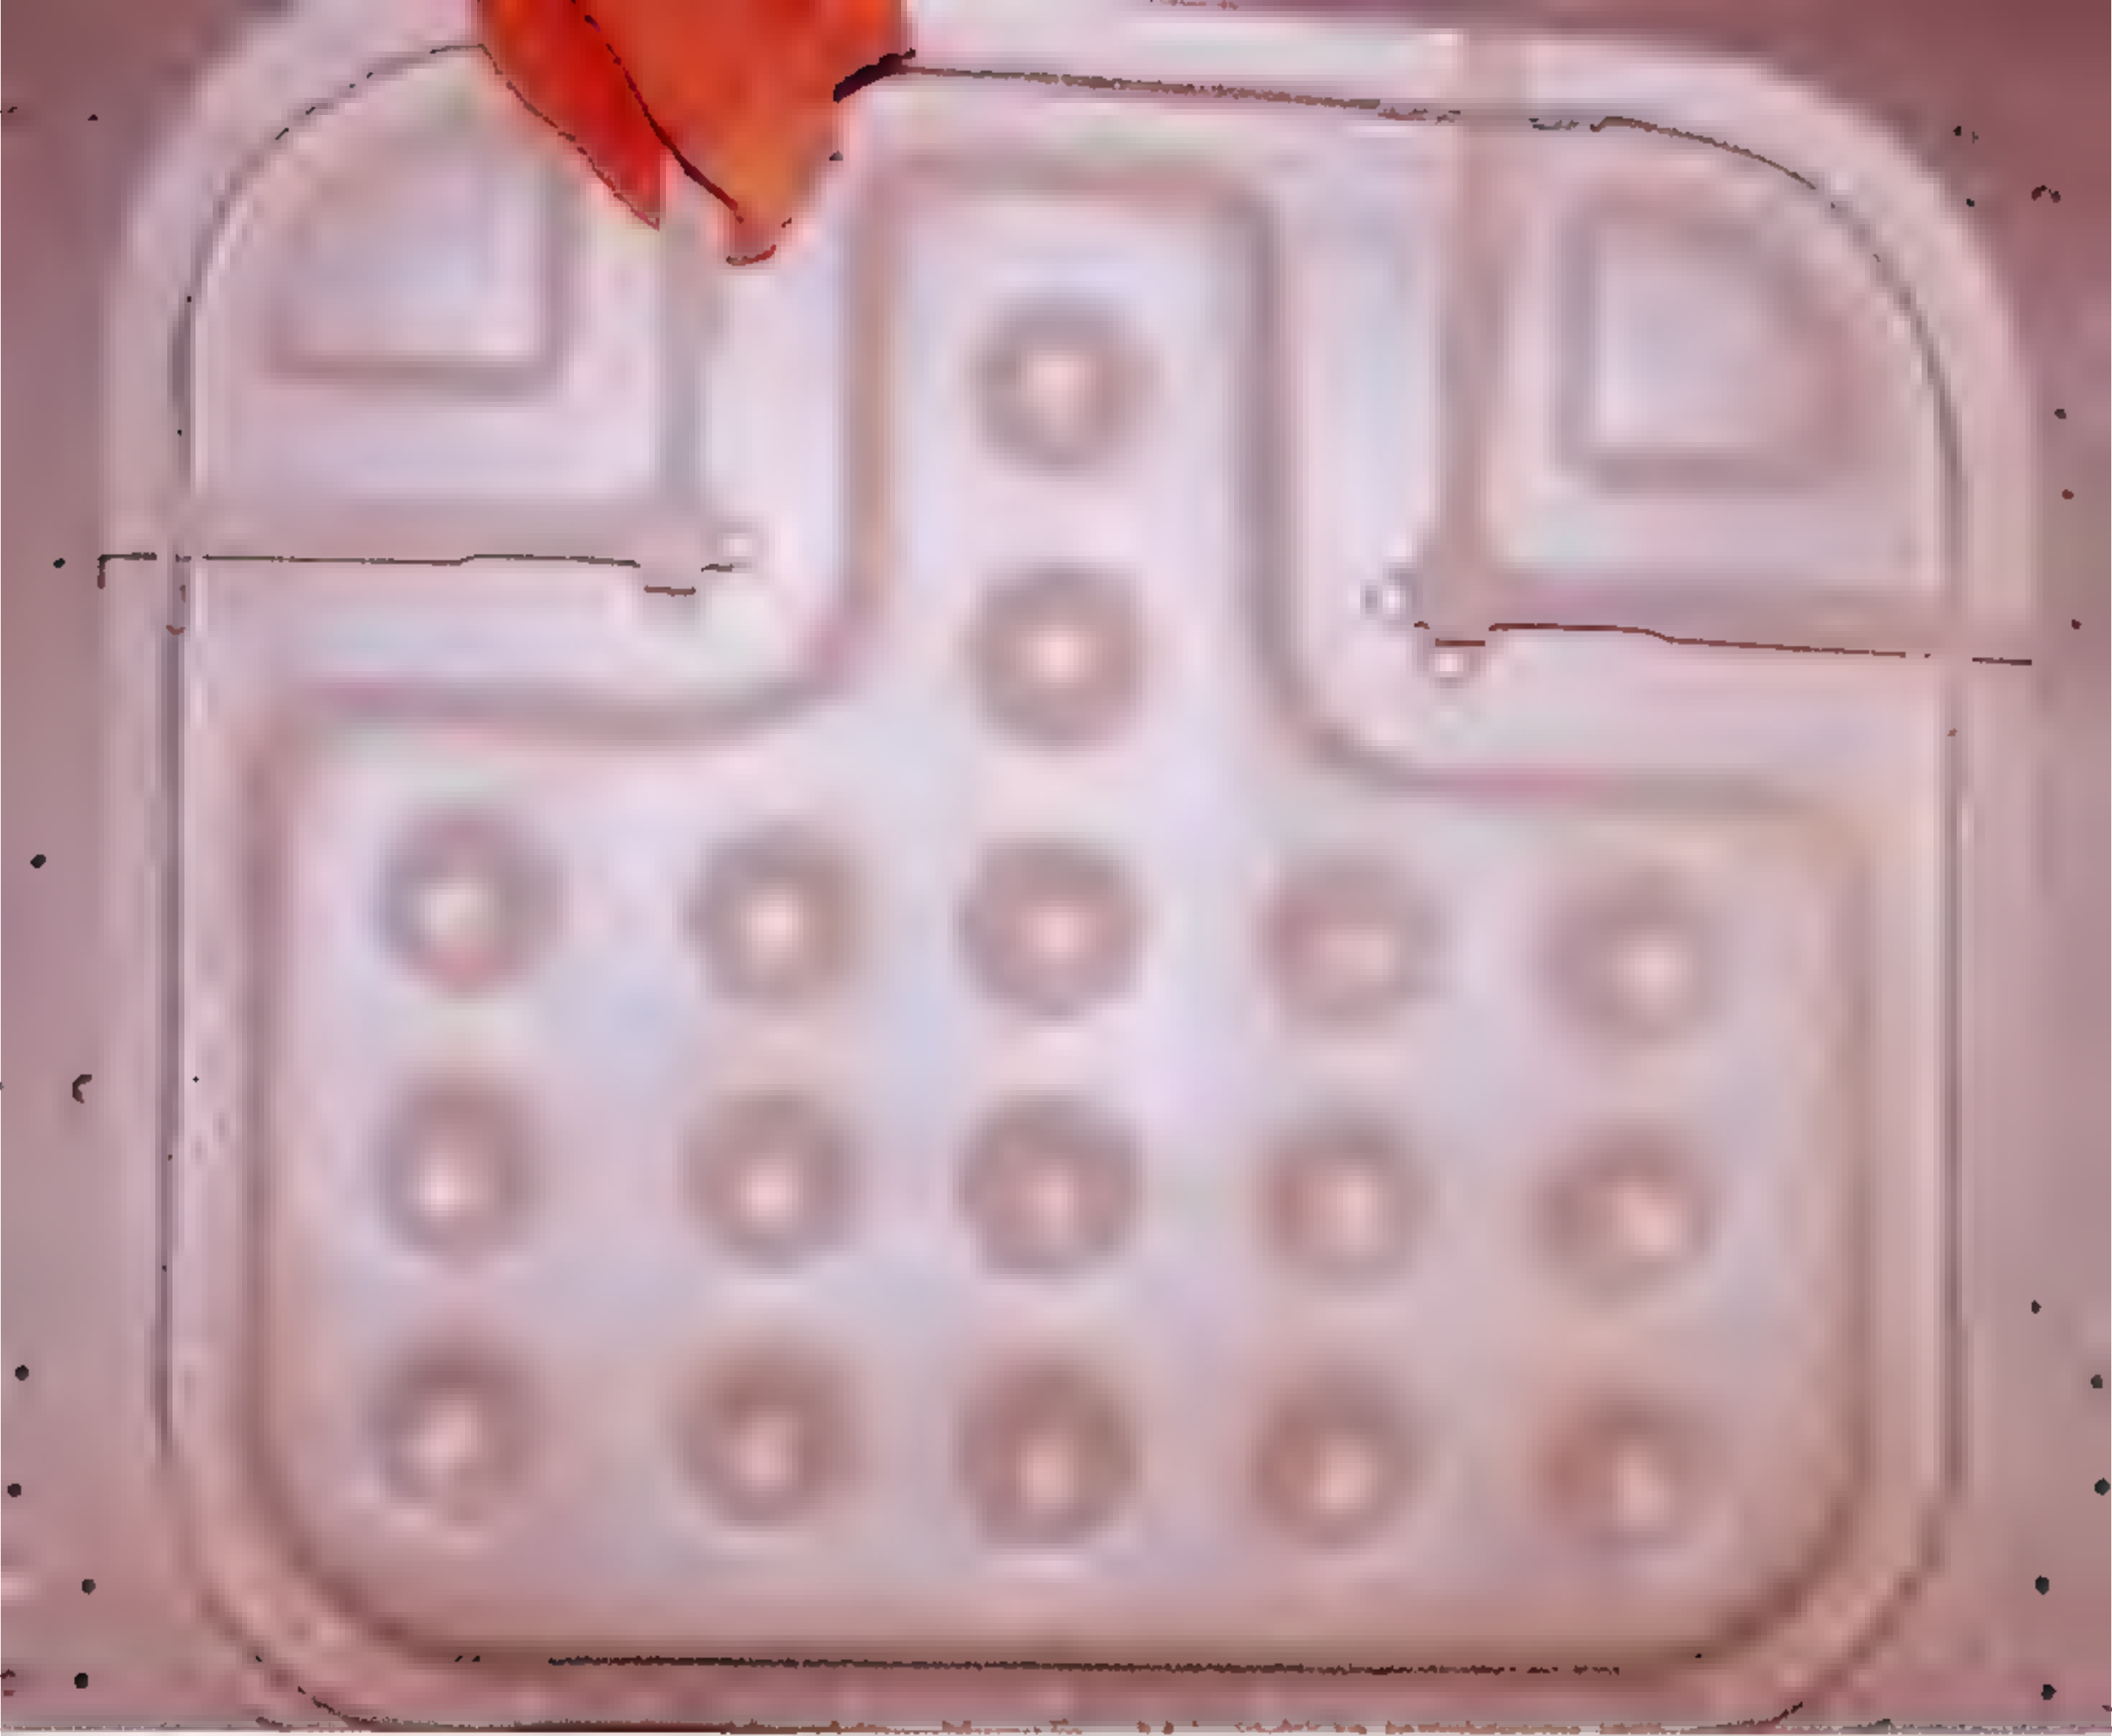
(Above) This fuselage access door on an Fw 190A-3 under restoration at Rio Hondo, Texas was the type of door used on Fw 190A-0s through A-4s. This hatch was rectangular and set low into the port fuselage aft of the cockpit. The interior 'waffle pattern' stiffening was common to early Fw 190s. The door swung upward on the hinge and four latching points secured the door to the fuselage. (Houston)
